# Manhole Inspection Summary

Manhole # S31I\_\_028MH

**Location** Address: **Emory St**

Cross Street: **Dover St**

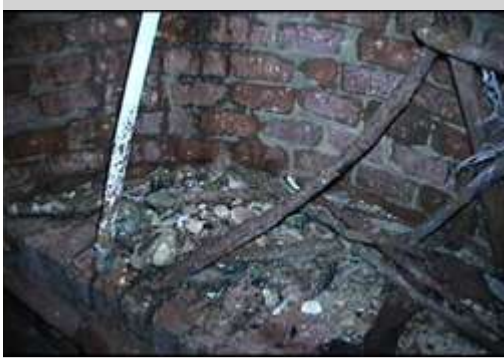
Miscellaneous

bench debris

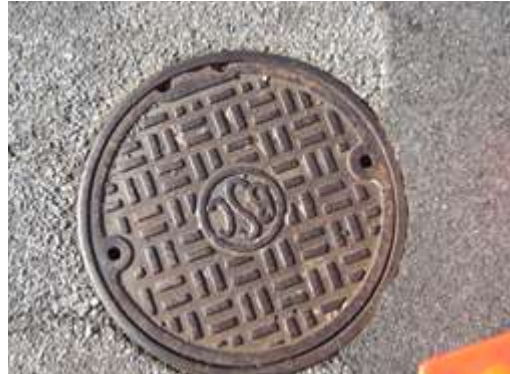
Miscellaneous

MH cover

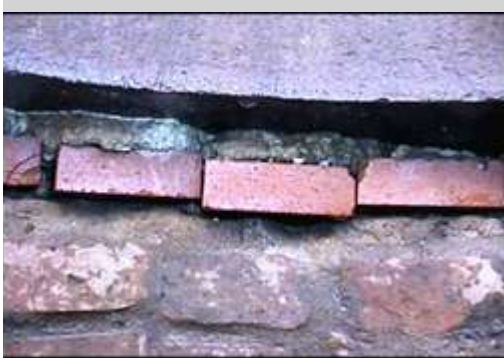
Defect 6

Condition: ☐ Sound ☐ Cracked ☐ Root Intrusion ☒ **Loose Brick** ☒ **Deteriorated**

Infiltration: ☐ None ☒ **Joint** ☐ Cracks ☒ **Mortar** ☐ Roots ☒ **Wall**

chimney deteriorated and loose bricks, infiltration at frame joint, mortar and wall

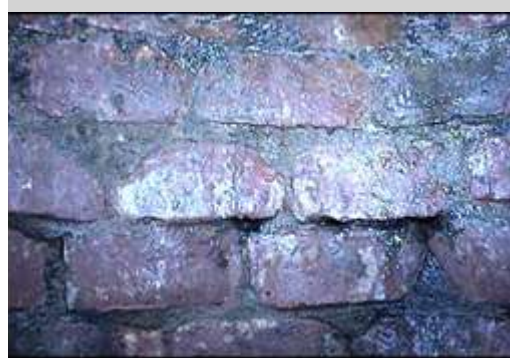
Defect 5

Infiltration: ☐ None ☐ Joint ☐ Cracks ☐ Mortar ☐ Roots ☒ **Wall**

corbel wall infiltration

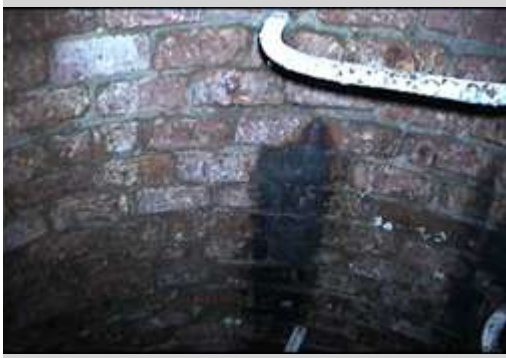
Defect 4

Infiltration: ☐ None ☐ Joint ☐ Cracks ☐ Mortar ☐ Roots ☒ **Wall**

barrel wall infiltration

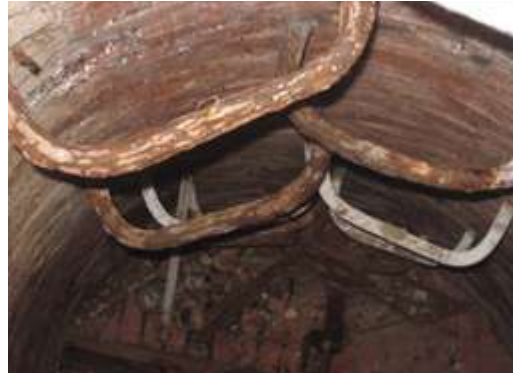
Defect 2

Count: **8** Missing: **0** ☒ **Corroded**

steps corroded

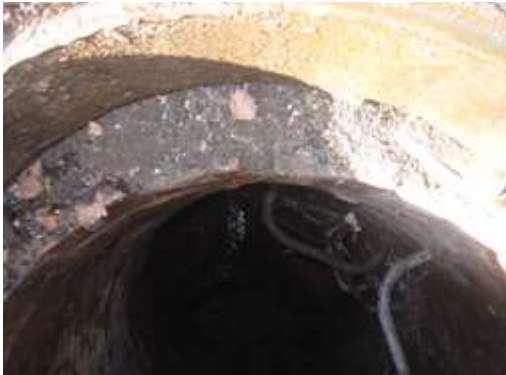
Defect 1

Offset: **3.** (in.)  
**25**

Condition: ☐ Sound ☐ Cracked ☒ **Leaks**

frame offset 3.25 inchs, frame infiltration  
at cover

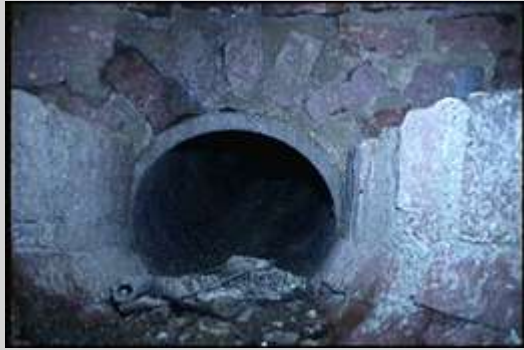
9 O'Clock Inflow

debris in channel
